**17 EWEN ROAD
HAMILTON, ONTARIO
TREE ASSESSMENT REPORT
FOR ZBA**

**PREPARED BY: RON KOUDYS LANDSCAPE
 ARCHITECTS INC**

DATE: AUGUST, 2022

RKLA PROJECT #: 22-147

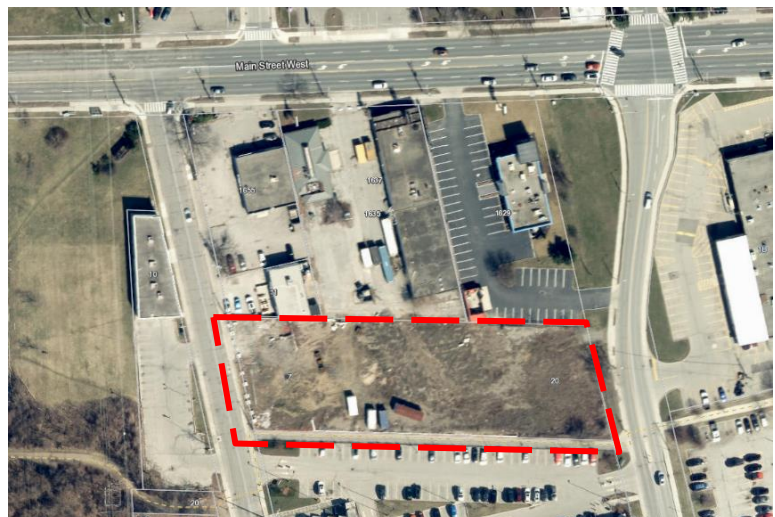
The scope of this tree inventory includes the subject site as well as trees within 3m of the subject site property line. Refer to Figure 1 for scope of tree inventory.

Field work was completed on March 19th, 2022. Field work consisted of tree images taken on site for later review by *Figure 1 - Image capture from City of Hamilton Mapping* certified arborist and the use of *Red dashed line - limit of tree inventory* aerial imagery to determine approximate canopy size. A topographic survey prepared by R.J. Burnside & Associates Limited was used to determine tree location/ownership. Note that not all trees assessed were located on the survey. Trees not included on the survey were located approximately via aerial imagery. Trees of all sizes within the City ROW, and trees with a minimum DBH of 10cm within the balance of the given scope were identified and assessed. Trees within the subject site were not tagged in the field.

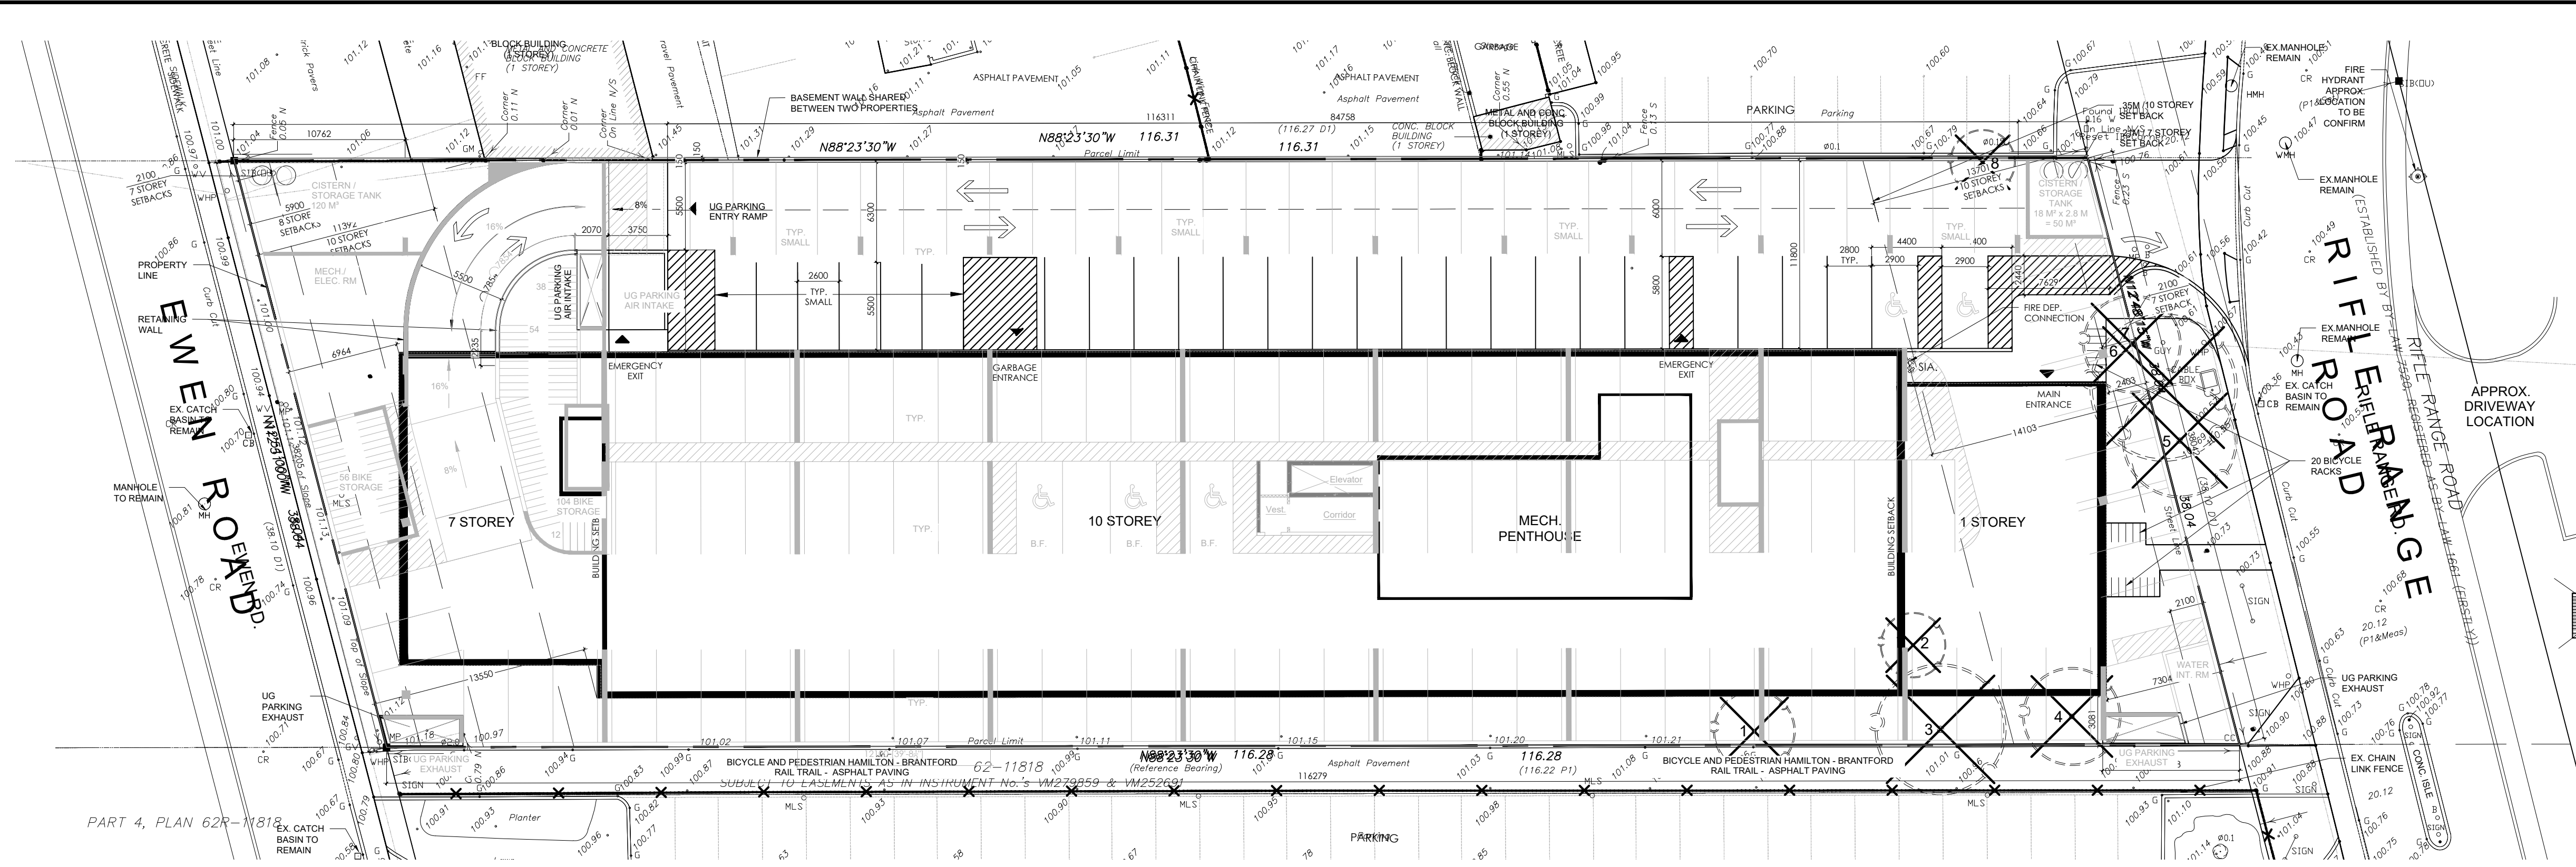
TREE PRESERVATION PLAN
SCALE = 1:250

(8) TREES RECOMMENDED TO BE REMOVED

GENERAL INFORMATION				SIZE		HEALTH & CONDITION				RECOMMENDATIONS	
ID#	BOTANICAL NAME	COMMON NAME	LOCATION	DBH (cm)	CANOPY RADIUS (m)	GROWN CONDITION	STRUCTURAL FORM	STRUCTURAL INTEGRITY	COMMENTS	EXPECTED CONSTRUCTION IMPACT (CRZ = critical root zone)	PRESERVE OR REMOVE
1	<i>Acer negundo</i>	Manitoba Maple	Subject Site	-18, 15, 12, 11, 6	2.5	3	Poor	Poor	Multi-stem 6, grown through fence, primary union at grade, growing between concrete block and fence	Conflict with proposed site grading & poor tree condition	Remove
2	<i>Robinia pseudoacacia</i>	Black Locust	Subject Site	-14, 12	2	5	Fair	Fair	Multi-stem 2, primary union just above grade, included bark at primary union	Conflict with proposed site grading & poor tree condition	Remove
3	<i>Ulmus spp.</i>	Elm	Subject Site	-50, 22, 20	4	4	Poor	Poor	Multi-stem 3, grown through fence, cavities at seams, significant deadwood, gnarly base	Conflict with proposed site grading & poor tree condition	Remove

4	<i>Ulmus spp.</i>	Elm	Subject Site	-15, 12, 10	3	5	Poor	Fair	Multi-stem 4, low crown, primary union just above grade, deadwood	Conflict with proposed site grading & poor tree condition	Remove
5	<i>Acer negundo</i>	Manitoba Maple	Subject Site	-25, 20, 18, 15, 15, 12, 10, 8, 8	3.5	3	Fair	Fair	Multi-stem 9, significant deadwood	Conflict with proposed site grading & poor tree condition	Remove
6	<i>Acer negundo</i>	Manitoba Maple	Subject Site	-25, 22, 20, 19, 12, 10, 10, 8	4.5	4	Fair	Fair	Multi-stem 9, primary unions at grade, deadwood, epicormic growth	Conflict with proposed site grading & poor tree condition	Remove
7	<i>Acer negundo</i>	Manitoba Maple	Subject Site	15, 15, 12, 11, 8, 6	3	4	Fair	Fair	Multi-stem 6, primary unions at grade, epicormic growth	Conflict with proposed site grading & poor tree condition	Remove
8	<i>Acer negundo</i>	Manitoba Maple	Subject Site	12, 12, 9, 8, 6	2	3	Poor	Poor	Multi-stem 5, grown through fence, primary union at grade, deadwood	Conflict with proposed site grading & poor tree condition	Remove

- a) ACQUIRE NECESSARY CONSENT FROM NEIGHBOURING LAND OWNERS FOR THE REMOVAL OF BOUNDARY TREES AND TREES BEYOND THE SUBJECT SITE.
- b) TREES APPROVED FOR REMOVAL ARE TO BE CLEARLY INDICATED IN THE FIELD (MARKED WITH SPRAY PAINT OR OTHER AGREED UPON METHOD) BY THE PROJECT ARBORIST OR LANDSCAPE ARCHITECT PRIOR TO ANY TREE REMOVAL OPERATIONS. ALL REMOVALS TO BE UNDERTAKEN BY AN ISA CERTIFIED ARBORIST.

- c) IN ACCORDANCE WITH THE MIGRATORY BIRDS CONVENTION ACT, 1994, ALL REMOVALS MUST TAKE PLACE BETWEEN SEPTEMBER 1ST AND MARCH 31ST TO AVOID DISTURBING NESTING MIGRATORY BIRDS. IF TREE REMOVAL OCCURS BETWEEN APRIL 1ST AND AUGUST 31ST, A BIOLOGIST IS REQUIRED TO COMPLETE A SEARCH FOR NESTS. ONCE CLEARED, THE CONTRACTOR HAS 48 HOURS TO REMOVE. IF REMOVAL DOES NOT OCCUR WITHIN 48 HOURS, ANOTHER SEARCH WILL BE REQUIRED.

- d) CARE SHOULD BE TAKEN DURING THE FELLING OPERATION TO AVOID DAMAGING THE BRANCHES, STEMS, TRUNKS, AND ROOTS OF NEARBY TREES TO BE PRESERVED. WHERE POSSIBLE, ALL TREES ARE TO BE FELLED TOWARDS THE CONSTRUCTION ZONE TO MINIMIZE IMPACTS ON ADJACENT VEGETATION. ALL REMOVALS TO BE UNDERTAKEN BY AN ISA CERTIFIED ARBORIST.
