#### CORKTOWN

211 John St. South, Hamilton ON

#### TREE PROTECTION AND REMOVALS PLAN

**LANDSCAPE LAYOUT PLAN**

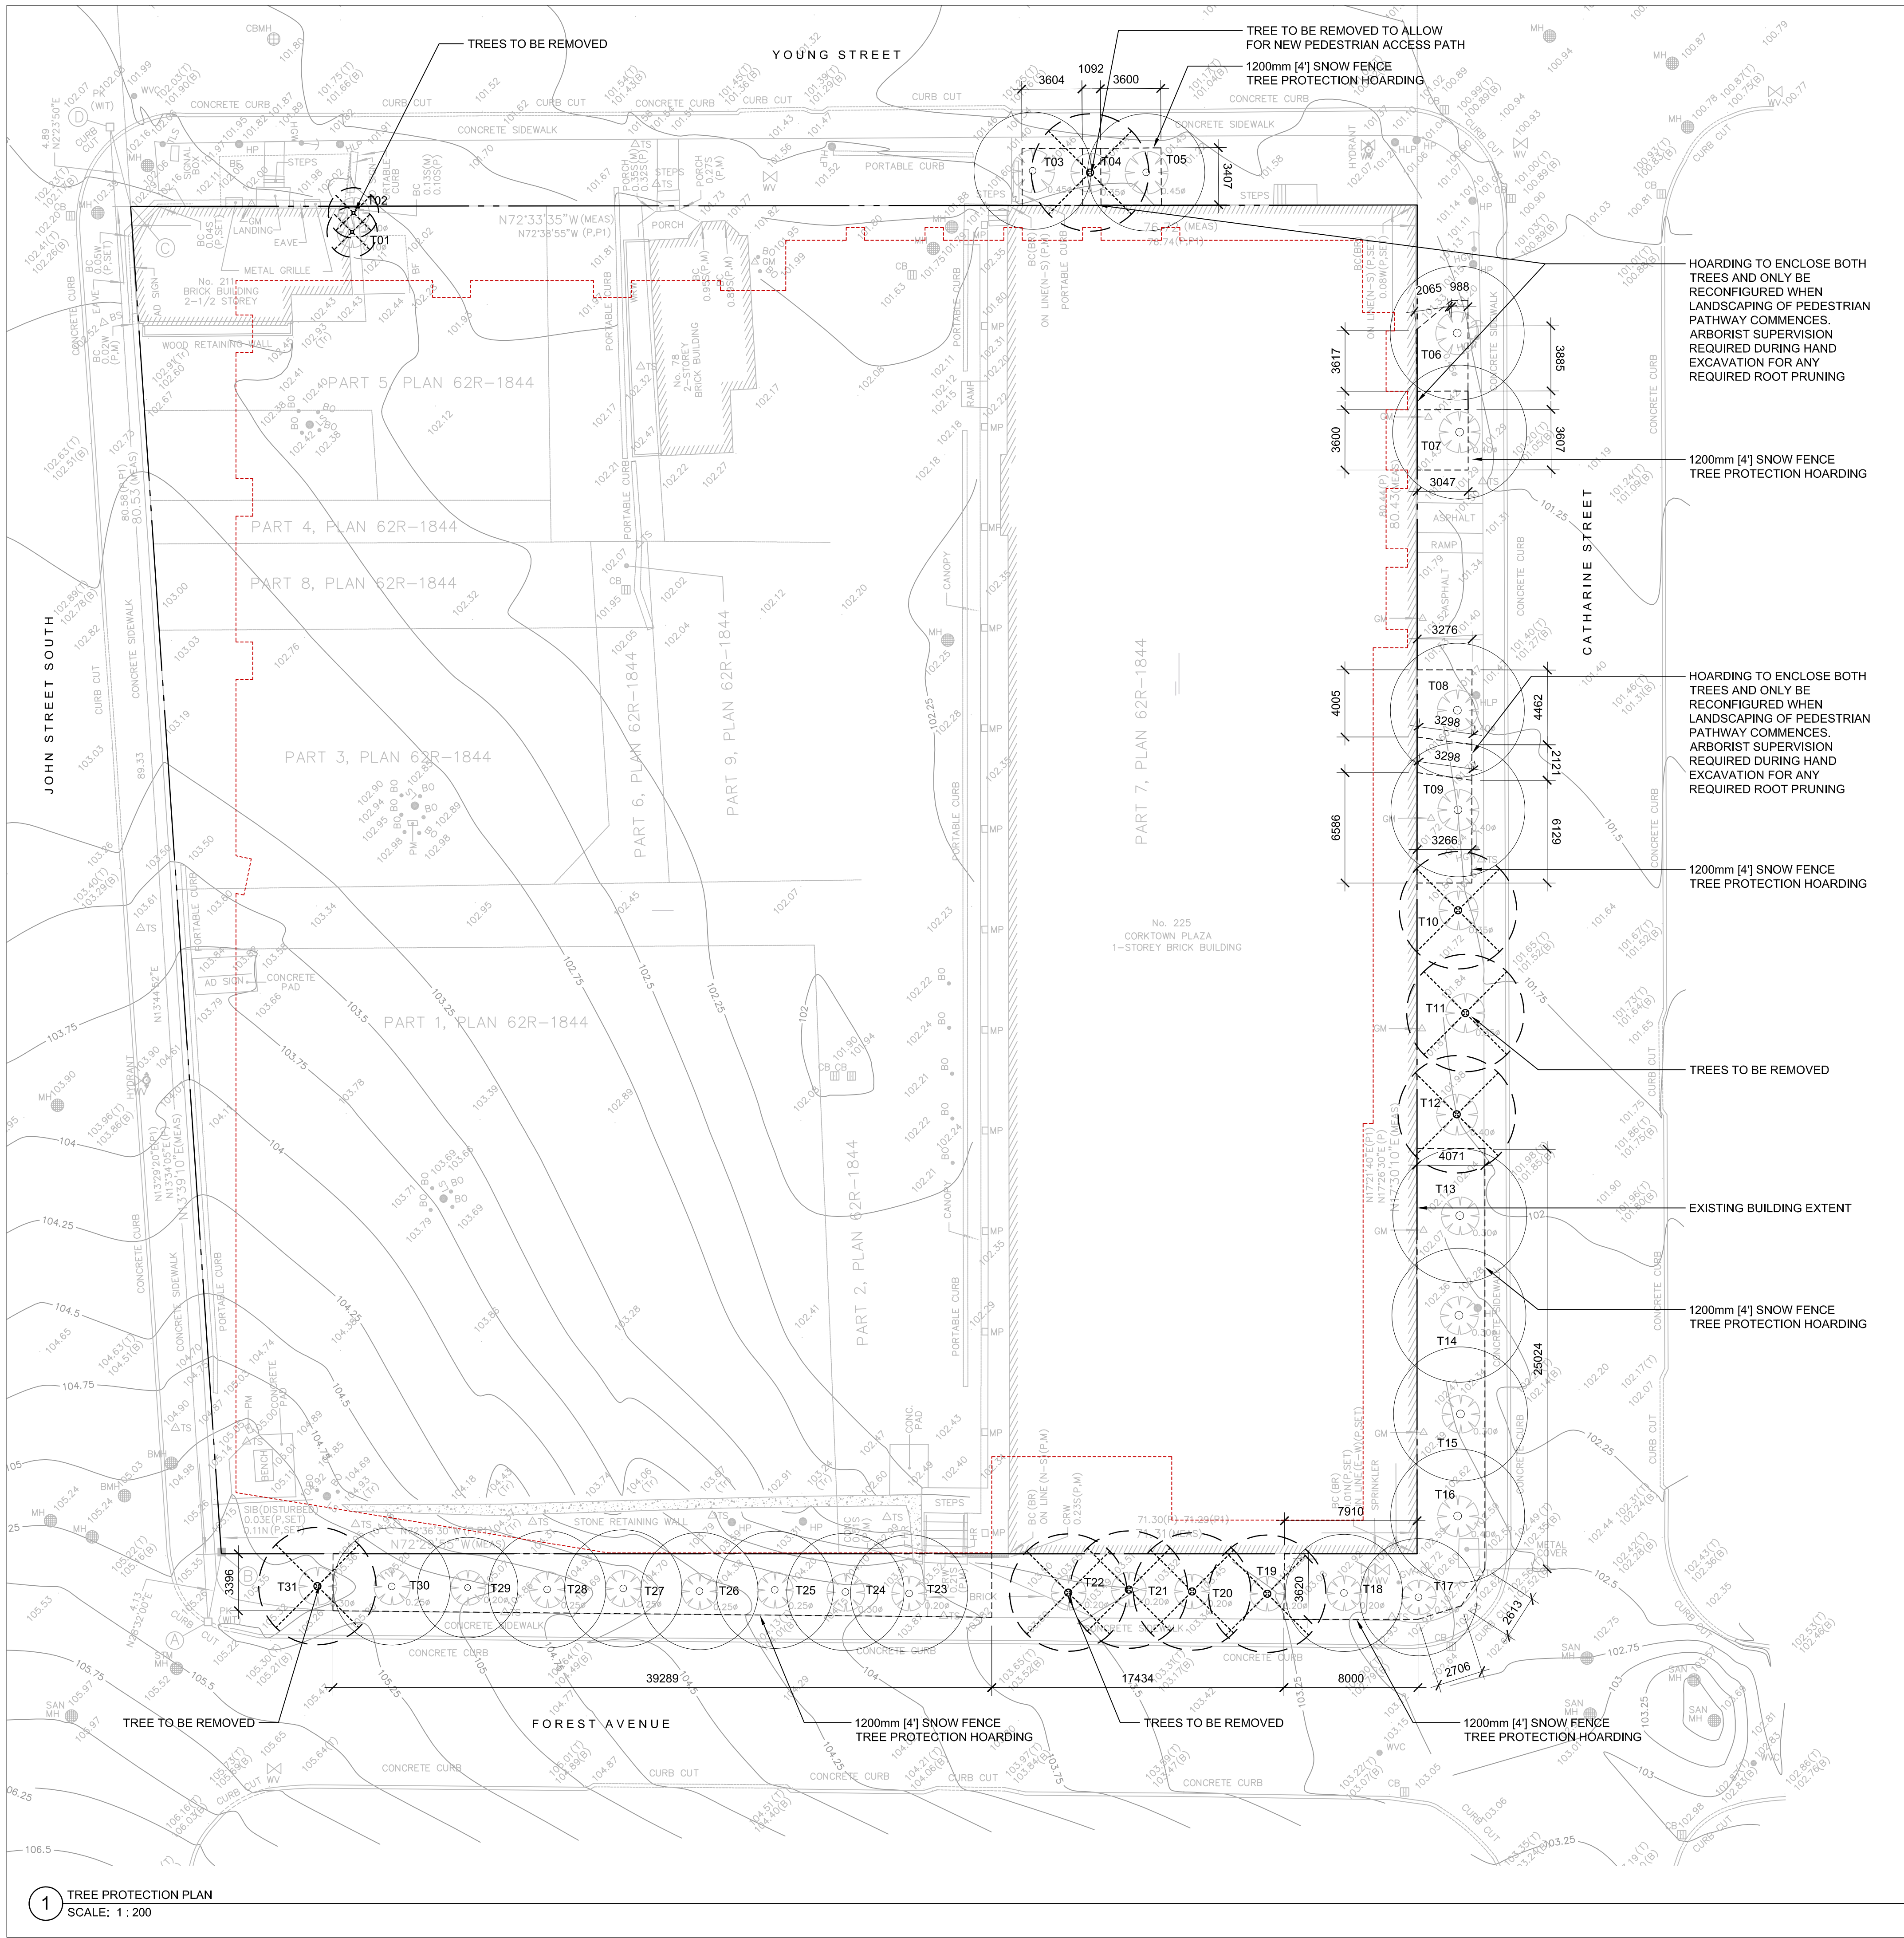
# L001

- TREE PROTECTION ZONE:**  
No construction activity including grade changes, surface treatments or excavations of any kind is permitted within the area identified on this plan as a Tree Protection Hoarding (TPH). No root cutting is permitted. No storage of materials or fill is permitted within the TPH. No movement or storage of vehicles or equipment is permitted within the TPH. The area(s) identified as a TPH must remain undisturbed at all times. Any landscape plantings or sodding which are indicated within the TPH must be done by hand. No mechanical equipment is permitted for use within the TPH. Any required topdressing for sod must not exceed 2.5 cm.

Trees located within the work area were inspected on April 10, 2018.
