**COMMERCIAL / RESIDENTIAL PROPERTY
2481 BARTON STREET EAST
STONEY CREEK (HAMILTON), ONTARIO
L8E 2X1**

**Phase II
Environmental Site Assessment**

Rubicon Job Number • R60315.1
Report Date • September 11, 2020

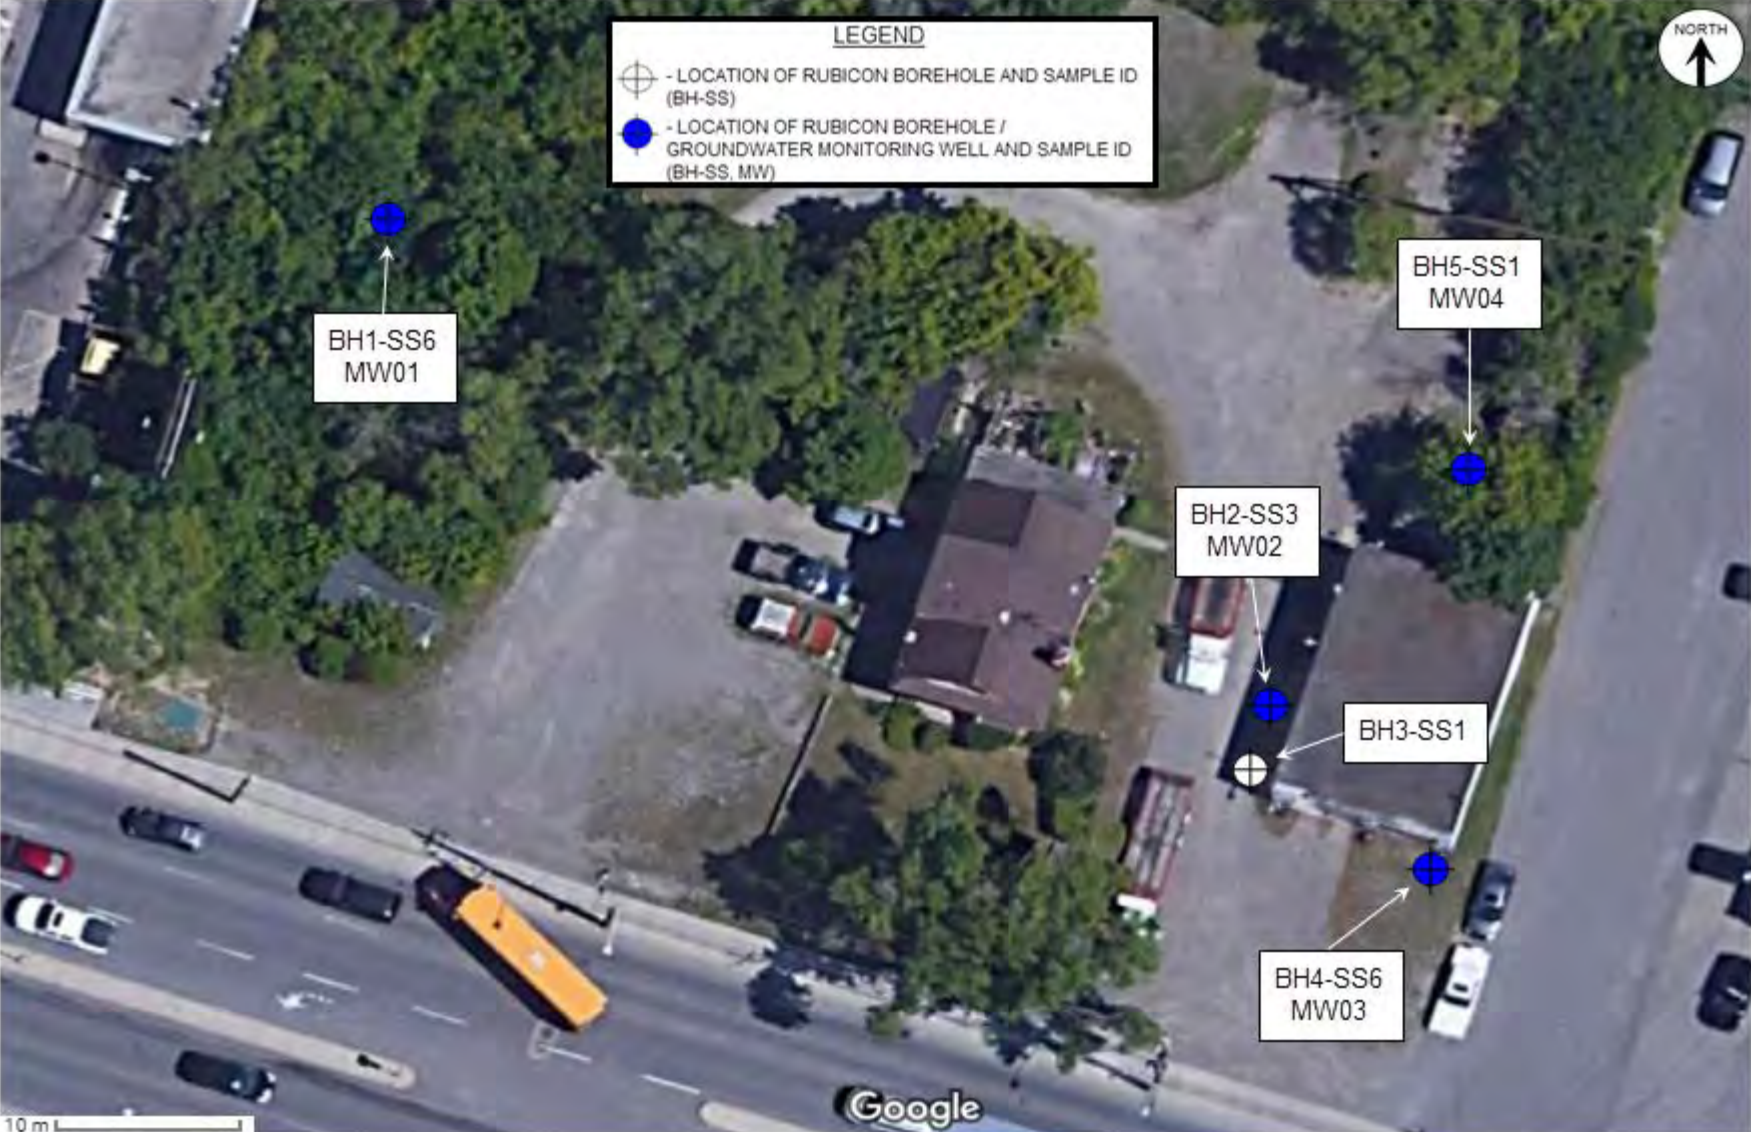
- LOCATION OF RUBICON BOREHOLE AND SAMPLE ID (BH-SS)
- LOCATION OF RUBICON BOREHOLE / GROUNDWATER MONITORING WELL AND SAMPLE ID (BH-SS, MW)

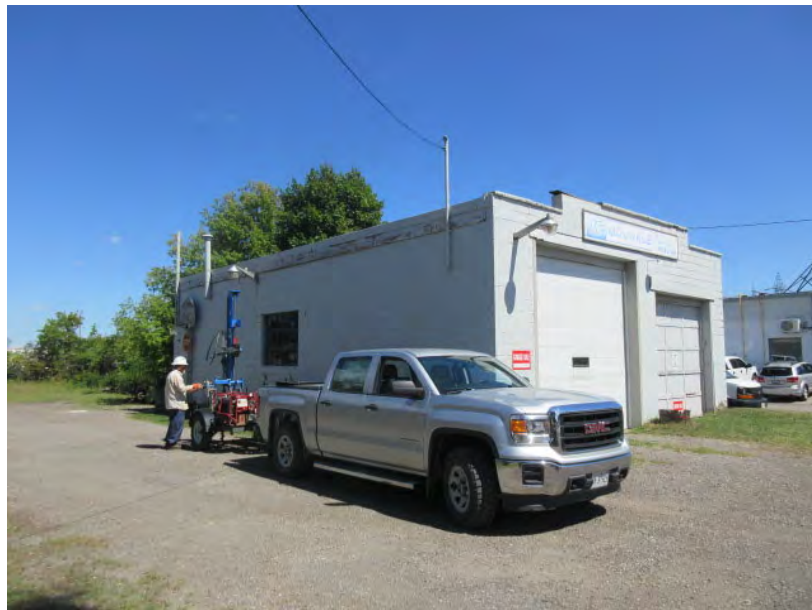
PHOTOGRAPH 3: ADVANCING BH2/MW02

The borehole program was completed on August 25, 2020 with the use of a *LST1A* trailer mounted drill rig. A combination of solid stem augers and 0.75 m long, 5 cm diameter split spoon samplers was utilized. All of the equipment that came into contact with subsurface conditions (split spoon samplers) during the drilling program were thoroughly cleansed with 'Alconox' powder mixed with water between each sampling interval to prevent possible cross contamination.

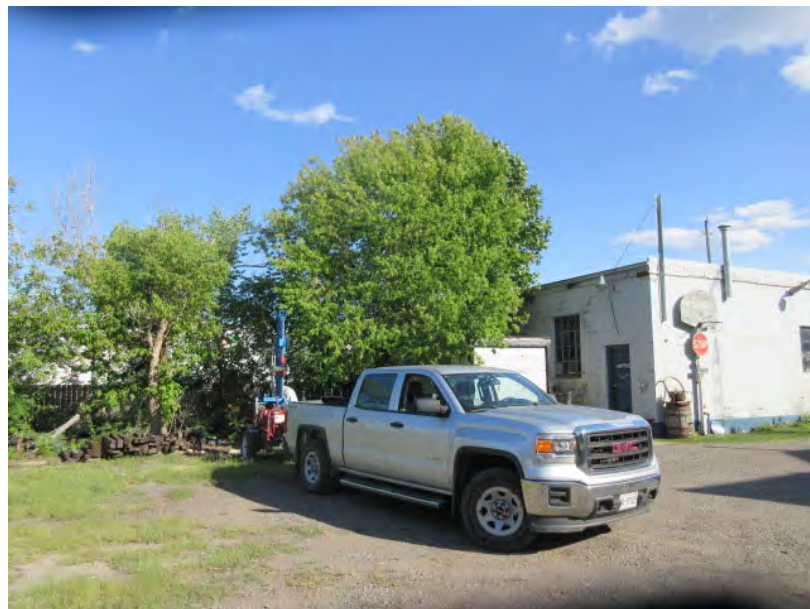
PHOTOGRAPH 4: ADVANCING BH5/MW04
