**17 EWEN ROAD
HAMILTON, ONTARIO
TREE ASSESSMENT REPORT
FOR ZBA**

**PREPARED BY: RON KOUDYS LANDSCAPE
 ARCHITECTS INC**

DATE: AUGUST, 2022

RKLA PROJECT #: 22-147

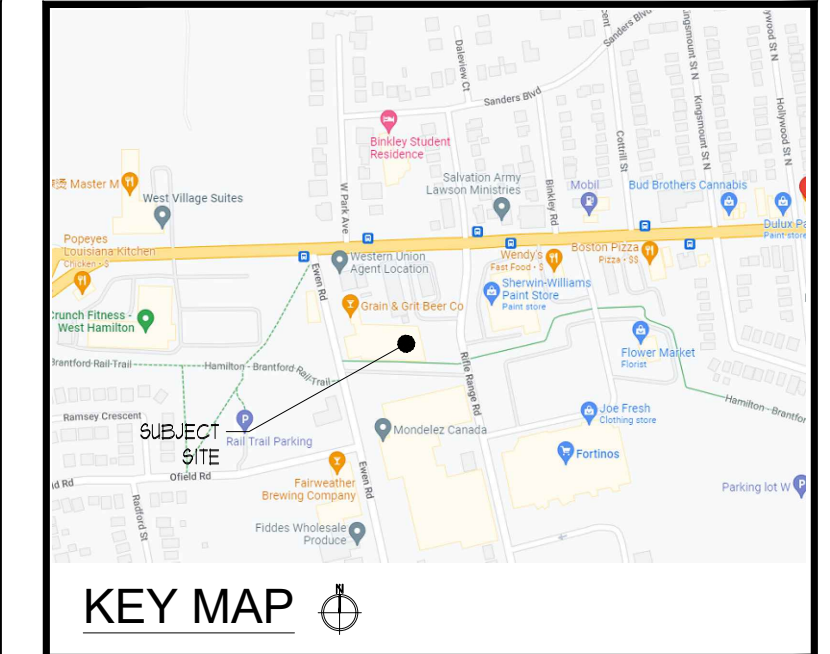
TREE PRESERVATION PLAN
SCALE = 1:250

(8) TREES RECOMMENDED TO BE REMOVED

- d) CARE SHOULD BE TAKEN DURING THE FELLING OPERATION TO AVOID DAMAGING THE BRANCHES, STEMS, TRUNKS, AND ROOTS OF NEARBY TREES TO BE PRESERVED. WHERE POSSIBLE, ALL TREES ARE TO BE FELLED TOWARDS THE CONSTRUCTION ZONE TO MINIMIZE IMPACTS ON ADJACENT VEGETATION. ALL REMOVALS TO BE UNDERTAKEN BY AN ISA CERTIFIED ARBORIST.
